Wall Morphology in Historic Buildings in Pondicherry

Hareesh Haridasan and Arun Menon

Tekton

Volume 5, Issue 2, September 2018

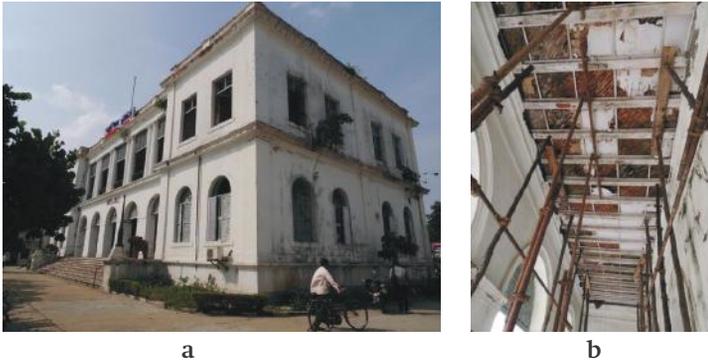
Figure 2: (a) La Mairie de Pondicherry before collapse; (b) Condition of verandah before collapse
(Image Credits – NCSHS, IIT Madras)

This 147 years old structure showed distress due to improper maintenance. Most of the structural elements were distressed. The distress was caused due to moisture and plaster had decayed severely. Cracks were observed on the masonry as well as on the Madras Terrace Floor (Figure 2). The structure of historical and architectural landmark value was taken up for repair and restoration but

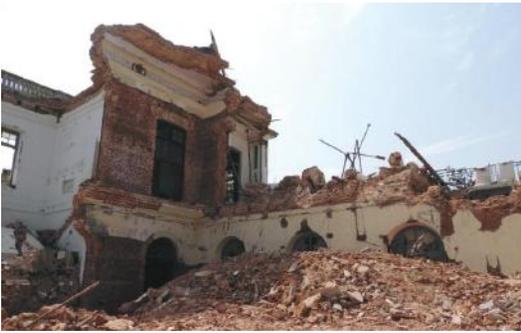
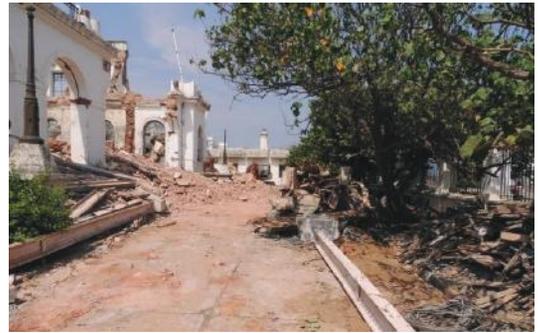
Figure 3: La Mairie de Pondicherry after collapse (Image Credits – NCSHS, IIT Madras)

collapsed while the work was in progress (Figure 3) (TNN, 2014).

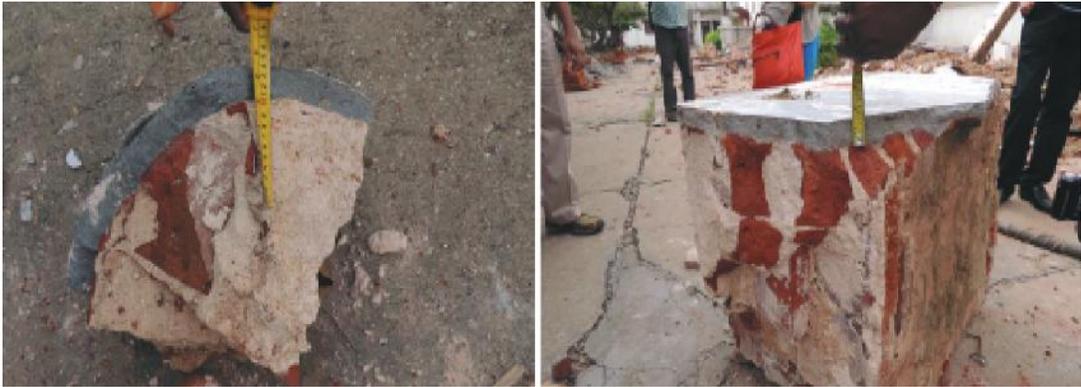
Figure 4: Load bearing masonry wall portions from the debris showing thick cement plaster. (Image Credits – NCSHS, IIT Madras)

In past two decades when the structure was in service, renovation works were undertaken by the Public Works Department (PWD) -Government of Puduchery in which the brickwork was plastered from the exterior and interior with a thick layer of cement plaster. **Figure 4** illustrates the presence of a thick cement plaster. For a structural masonry wall in brickwork with mud mortar and lime mortar, with no damp-proofing course and subjected to rising dampness by capillary action, the impervious layer of cement plastering is a serious hazard as it does not permit the rising dampness to evaporate through the wall plaster. Original plastering in lime or mud would have permitted exit of moisture from the walls, owing to the porosity of the plaster, thereby keeping the masonry wall in good structural health (**Figure 5**). Moreover, regular refurbishment of the plaster and repointing of bed-joint mortar are essential in such walls as the cyclic process of escape of moisture leads to deterioration of plaster and bedding mortar, the sacrificial layer (NCSHS, 2015).

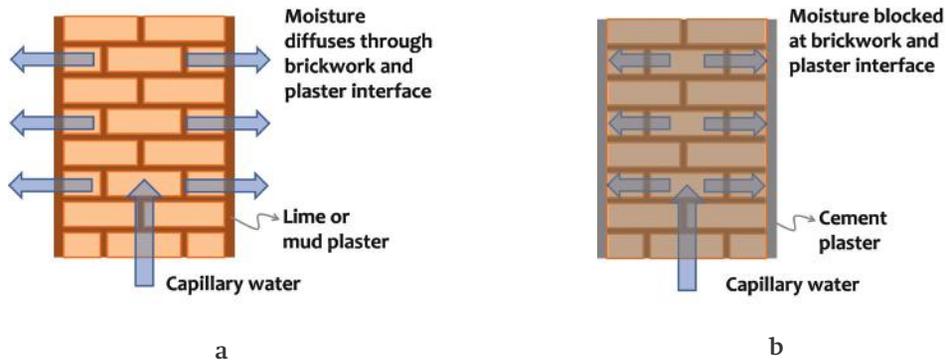
The thick cement plaster was on one hand trapping the moisture within the walls and on the other hand, was playing a structural role by confining the weakened walls and sustaining the load-carrying capacity of the wall.

Figure 5: (a) Illustration showing behavior of moisture in brick masonry with mud/lime plaster; (b): Illustration showing moisture blocked in brickwork and plaster interface due to cement plaster

The thick cement plaster was on one hand trapping the moisture within the walls and on the other hand, was playing a structural role by confining the weakened walls and sustaining the load-carrying capacity of the wall. The use of cement plastering in such a building can be described as the single-most deleterious intervention that gradually led to the structural failure of the building (NCSHS, 2015). Thick rich cement plaster has clearly been observed in the load-bearing walls of the Mairie building (refer Figure 4). Possibly, the confinement provided by the cement plaster layer to a highly deteriorated brick wall in mud mortar was so critical as to lead to collapse on de-plastering.

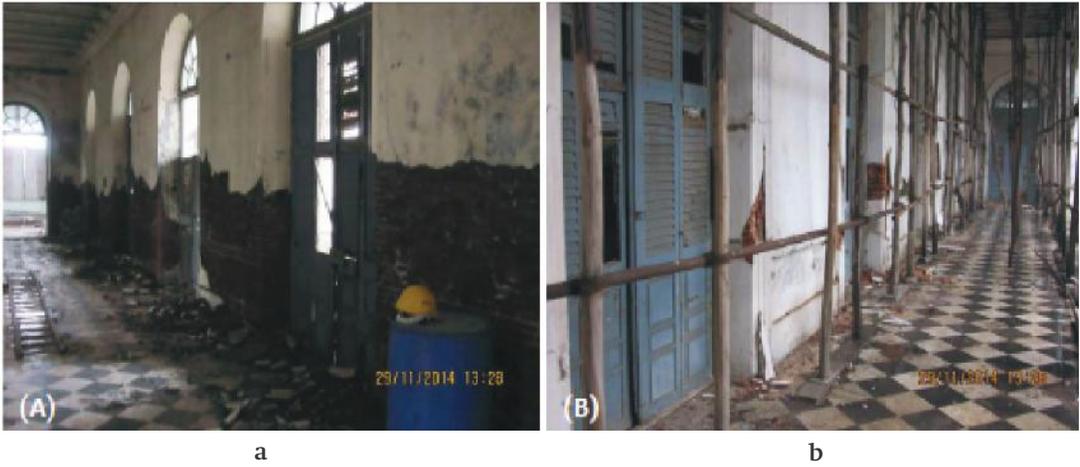
The collapse of the La Mairie de Pondicherry has been understood to have occurred after the removal of the cement plaster on the interior face of one of the primary load-bearing walls

in the north-south axis. The removal of the cement plaster approximately 4 cm thick lead to compression failure in the load-bearing walls. This is confirmed by the formation of vertical cracks and bulging of plaster, which is a very rare phenomenon. Cement plastering being impervious, would trap the moisture, and retain it within the masonry walls which were laid in mud mortar and lime mortar. Wet mud has poor or no compressive strength; wet compressive strength of bricks is also lower than the dry compressive strength.

Examination of the base and plinth of the wall that collapsed first shows no discernible signs of crushing at the base, implying that the crushing failure of the brick masonry at approximately one meter above the finished ground level caused the collapse of the wall. This subsequently triggered the collapse of the floor and adjoining walls. The foundation of the structure in brickwork with lime mortar and random rubble masonry with lime mortar was in excellent condition even after the structural failure.

Figure 6:(a) Load bearing walls with partially removed plaster; (b) Delamination and bulging of plaster due to crushing failure. (Image Credits – INTACH Pondicherry)

4. Removing plaster without assessment must be avoided. Removal if needed should be undertaken with proper guidance and executed only in segments. Actions due to water ingress in masonry walls have been a serious concern. It has been the cause of maximum decay in majority of historic masonry structures. However, it should be emphasized that the structural health of such typologies can be assured with regular maintenance and refurbishment of bed-joint mortars by repointing, and plaster.

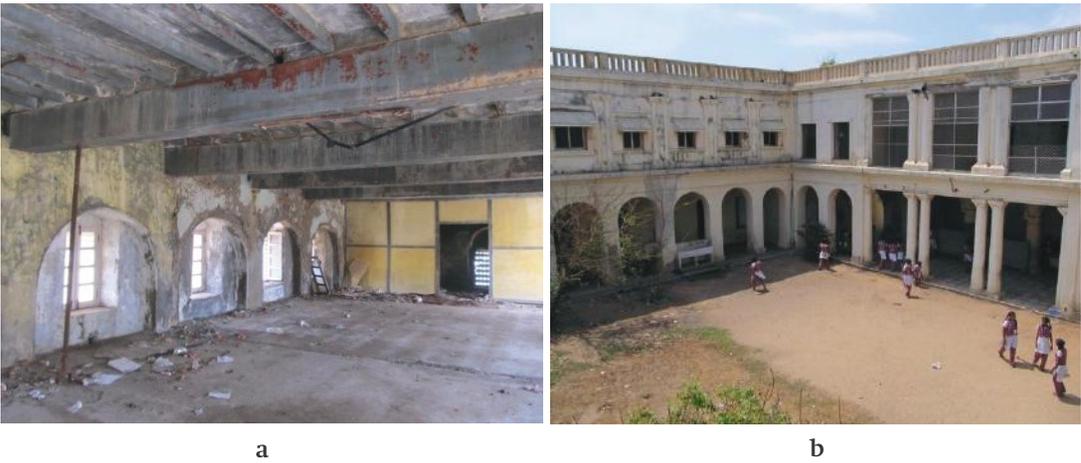
Figure 7:(a) Distressed beam in upper floor of Pensionnat de Jeunes Filles; (b) View of Courtyard of Pensionnat de Jeunes Filles (Image Credits – NCSHS, IIT Madras)

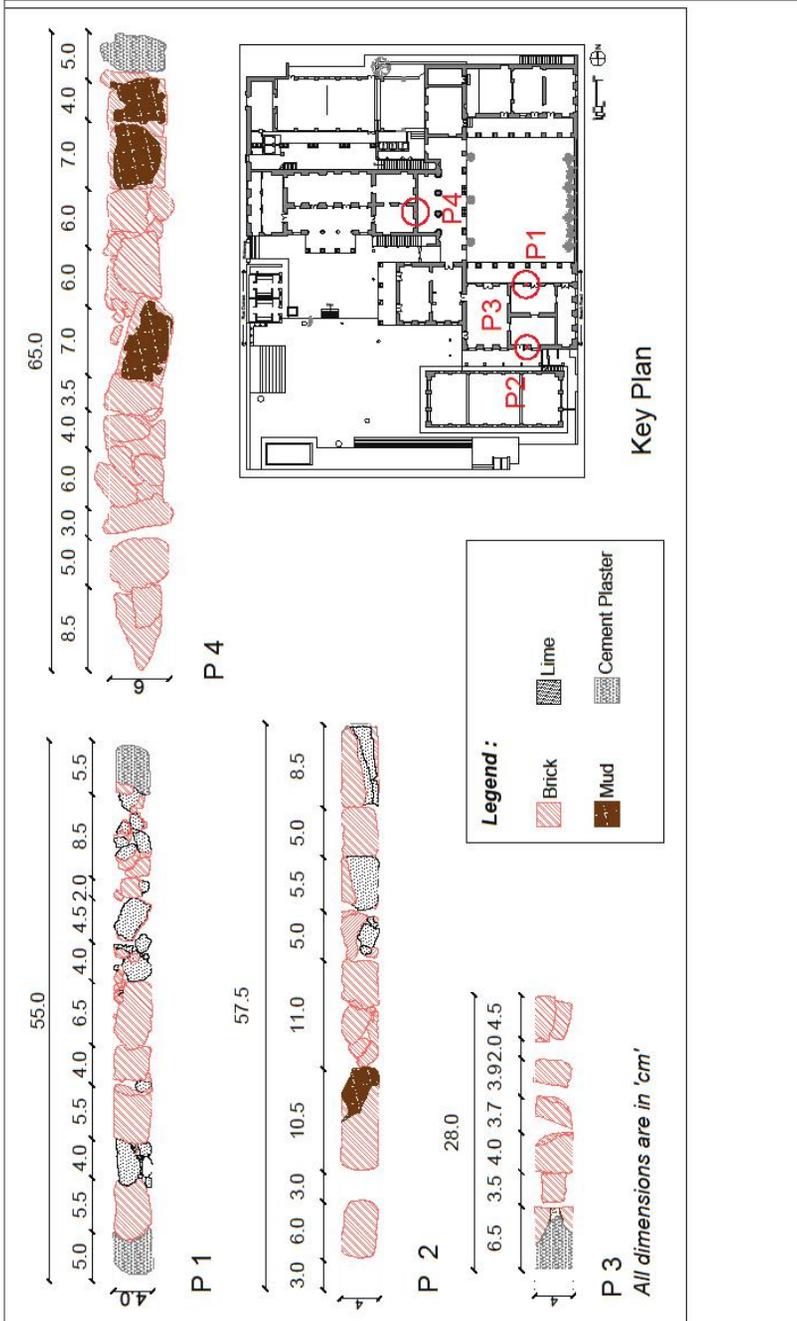
Figure 8: Masonry Core section from the school Pensionnat de Jeunes Filles.

Mairie. Wet coring process was followed for these structures (Figures 8, 9 10). The core samples extracted were of 4 cm and 6.5 cm. Core extraction is a powered process in which heat is generated. Wet coring is preferred in order to keep the machine cooled and the blades clean when it is in use. However, the water jet is sufficient to wash out the mud mortar and could lead to moisture ingress in masonry. This issue of binding mortar washing out is not noticed in cement or lime mortar.

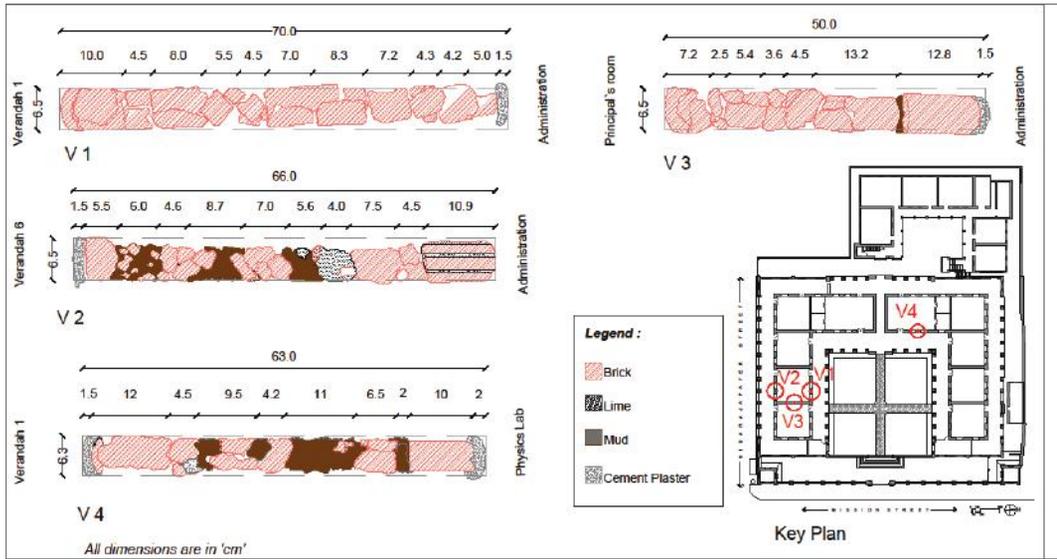
Figure 9: Masonry Core section from the VOC Government High School.

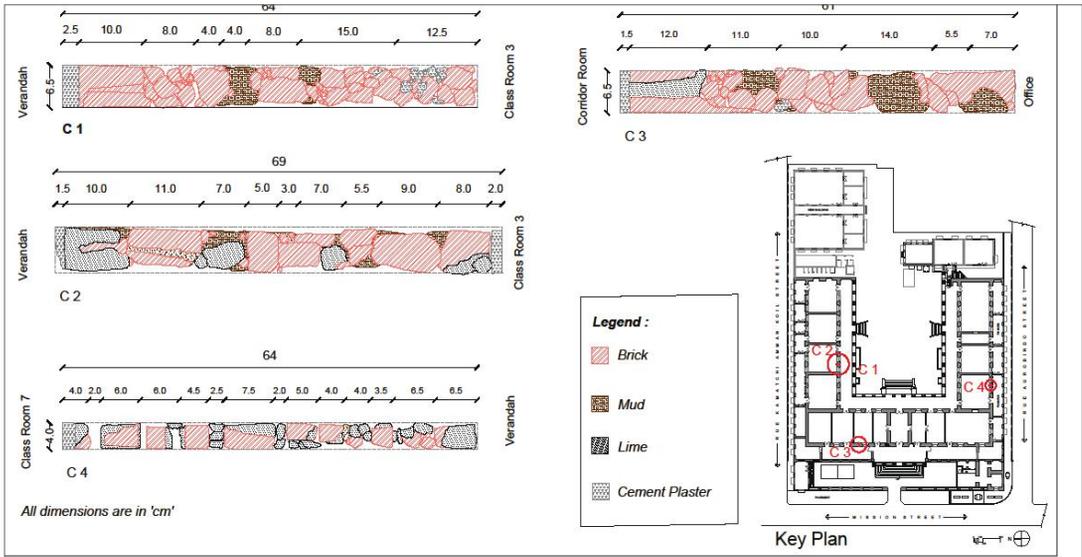
Figure 10: Masonry core section of Calve College

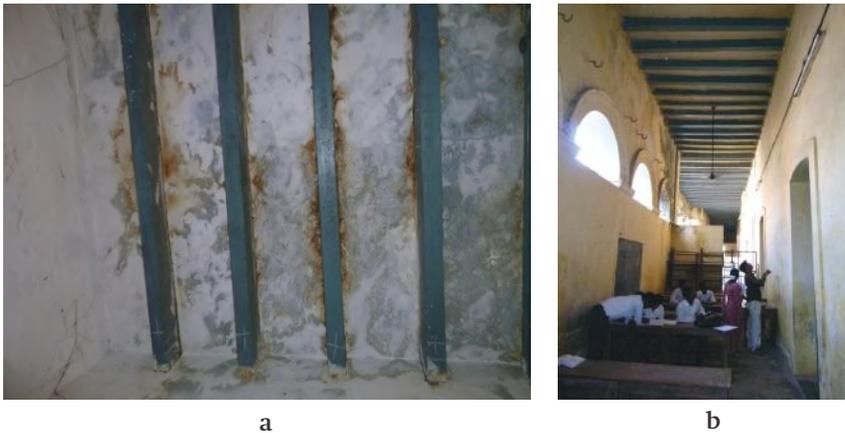
Figure 11:(a) Deterioration due to water seepage; (b) Verandah with later addition of Calve College (Image Credits – NCSHS, IIT Madras)
