Wall Morphology in Historic Buildings in Pondicherry

Hareesh Haridasan and Arun Menon

Tekton Volume 5, Issue 2, September 2018 pp. 34 - 49

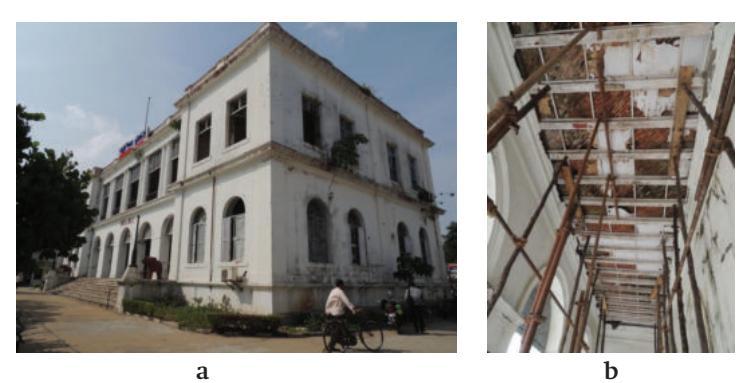
Figure 2: (a) La Mairie de Pondicherry before collapse; (b) Condition of verandah before collapse (Image Credits – NCSHS, IIT Madras)

This 147 years old structure showed distress due to improper maintenance. Most of the structural elements were distressed. The distress was caused due to moisture and plaster had decayed severely. Cracks were observed on the masonry as well as on the Madras Terrace Floor (**Figure 2**). The structure of historical and architectural landmark value was taken up for repair and restoration but collapsed while the work was in progress (**Figure 3**) (TNN, 2014).

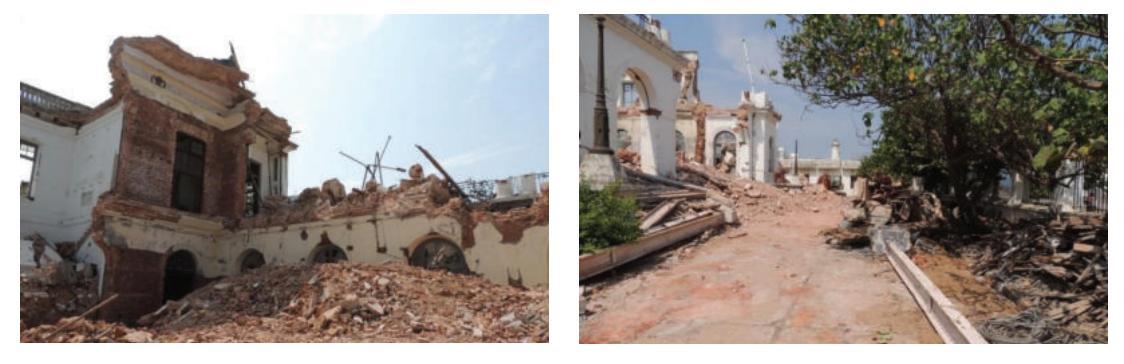
Figure 3: La Mairie de Pondicherry after collapse (Image Credits – NCSHS, IIT Madras)

The Reasons for the Collapse of La Mairie The collapse of the La Mairie de Pondicherry has been understood to have occurred after the removal of the cement plaster on the interior face of one of the primary load-bearing walls

in the north-south axis. The removal of the cement plaster approximately 4 cm thick lead to compression failure in the load-bearing walls. This is confirmed by the formation of vertical cracks and bulging of plaster, which is a very rare phenomenon. Cement plastering being impervious, would trap the moisture, and retain it within the masonry walls which were laid in mud mortar and lime mortar. Wet mud has poor or no compressive strength; wet compressive strength of bricks is also lower than the dry compressive strength.

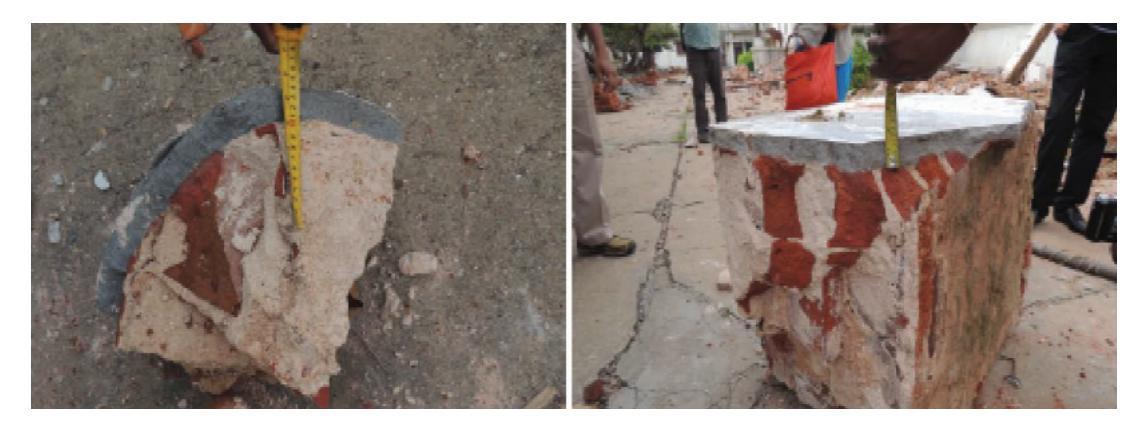
Figure 4: Load bearing masonry wall portions from the debris showing thick cement plaster. (Image Credits – NCSHS, IIT Madras)

In past two decades when the structure was in service, renovation works were undertaken by the Public Works Department (PWD) -Government of Puduchery in which the brickwork was plastered from the exterior and interior with a thick layer of cement plaster. Figure 4 illustrates the presence of a thick cement plaster. For a structural masonry wall in brickwork with mud mortar and lime mortar. with no damp-proofing course and subjected to rising dampness by capillary action, the impervious layer of cement plastering is a serious hazard as it does not permit the rising dampness to evaporate through the wall plaster. Original plastering in lime or mud would have permitted exit of moisture from the walls, owing to the porosity of the plaster, thereby keeping the masonry wall in good structural health (Figure 5). Moreover, regular refurbishment of the plaster and repointing of bed-joint mortar are essential in such walls as the cyclic process of escape of moisture leads to deterioration of plaster and bedding mortar, the sacrificial layer (NCSHS, 2015).

The thick cement plaster was on one hand trapping the moisture within the walls and on the other hand, was playing a structural role by confining the weakened walls and sustaining the load-carrying capacity of the wall. The use of cement plastering in such a building can be described as the single-most deleterious intervention that gradually led to the structural failure of the building (NCSHS, 2015). Thick rich cement plaster has clearly been observed in the load-bearing walls of the Mairie building (refer Figure 4). Possibly, the confinement provided by the cement plaster layer to a highly deteriorated brick wall in mud mortar was so critical as to lead to collapse on de-plastering.

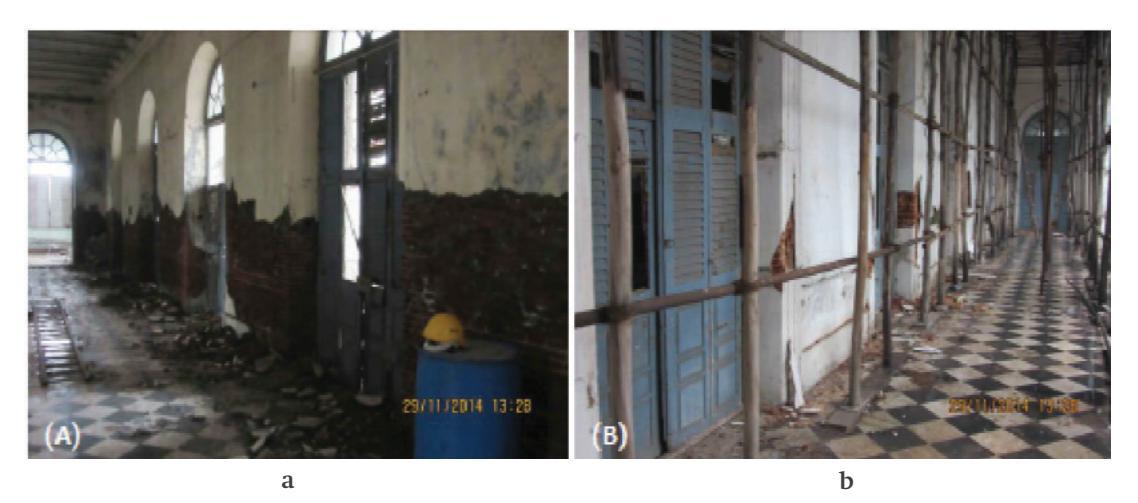
Compression tests on brickwork in lime mortar extracted from the collapsed structure, carried out at the Structural Engineering Laboratory of IIT Madras, showed that the compressive strength of the masonry was of the order of 2.0 N/mm2 (20 kg/cm2), which is a lower bound value for solid clay brickwork with lime mortar. The dry compressive strength of the brickwork with mud mortar would have been less than 1.0 N/mm2 (10 kg/cm2); however, this was not tested (NCSHS, 2015).

Figure 6:(a) Load bearing walls with partially removed plaster; (b) Delamination and bulging of plaster due to crushing failure. (Image Credits – INTACH Pondicherry)

4. Removing plaster without assessment must be avoided. Removal if needed should be undertaken with proper guidance and executed only in segments. Actions due to water ingress in masonry walls have been a serious concern. It has been the cause of maximum decay in majority of historic masonry structures. However, it should be emphasized that the structural health of such typologies can be assured with regular maintenance and refurbishment of bed-joint mortars by repointing, and plaster.

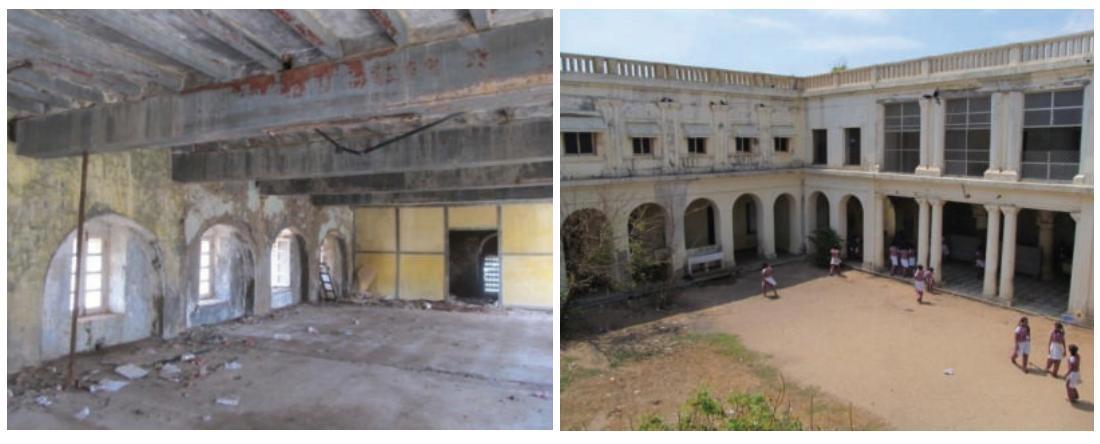
Figure 7:(a) Distressed beam in upper floor of Pensionnat de Jeunes Filles; (b) View of Courtyard of Pensionnat de Jeunes Filles (Image Credits – NCSHS, IIT Madras)

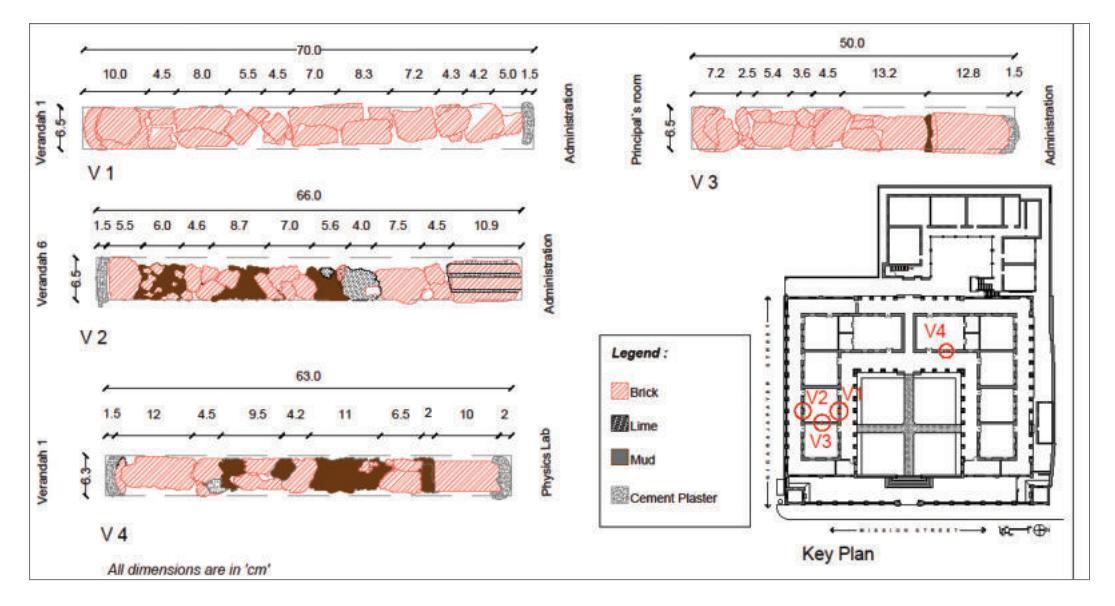
Figure 9: Masonry Core section from the VOC Government High School.

Mairie. Wet coring process was followed for these structures (**Figures 8, 9 10**). The core samples extracted were of 4 cm and 6.5 cm. Core extraction is a powered process in which heat is generated. Wet coring is preferred in order to keep the machine cooled and the blades clean when it is in use. However, the water jet is sufficient to wash out the mud mortar and could lead to moisture ingress in masonry. This issue of binding mortar washing out is not noticed in cement or lime mortar.

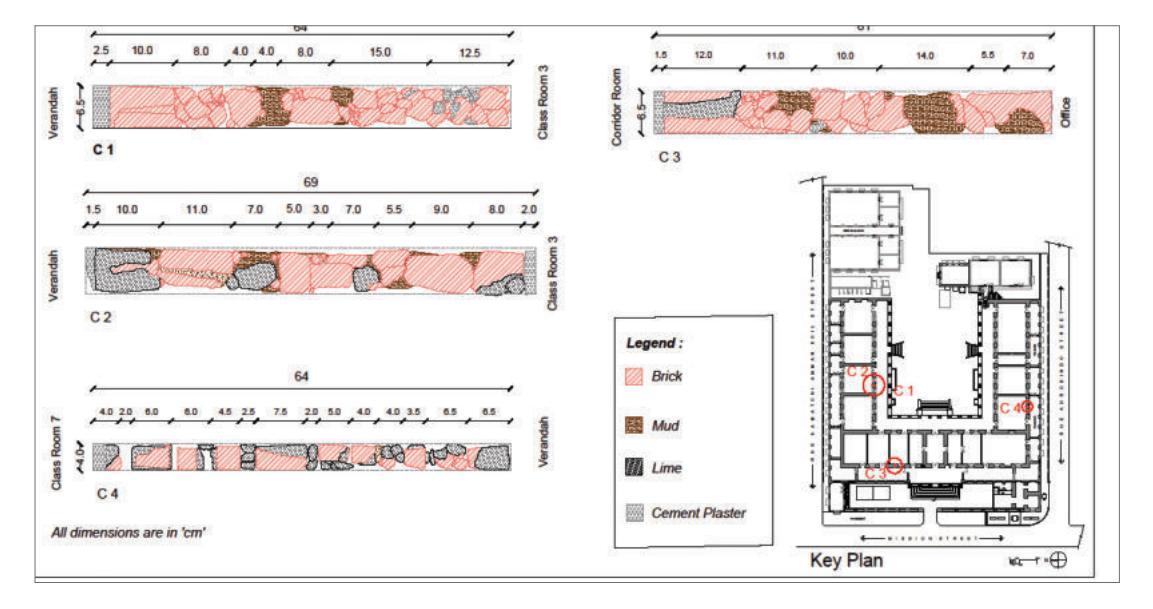
Figure 10: Masonry core section of Calve College

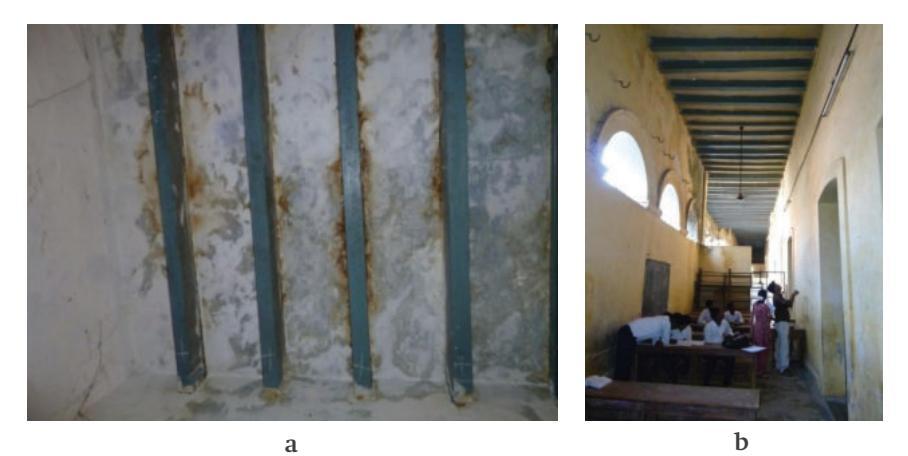
Figure 11:(a) Deterioration due to water seepage; (b) Verandah with later addition of Calve College (Image Credits – NCSHS, IIT Madras)

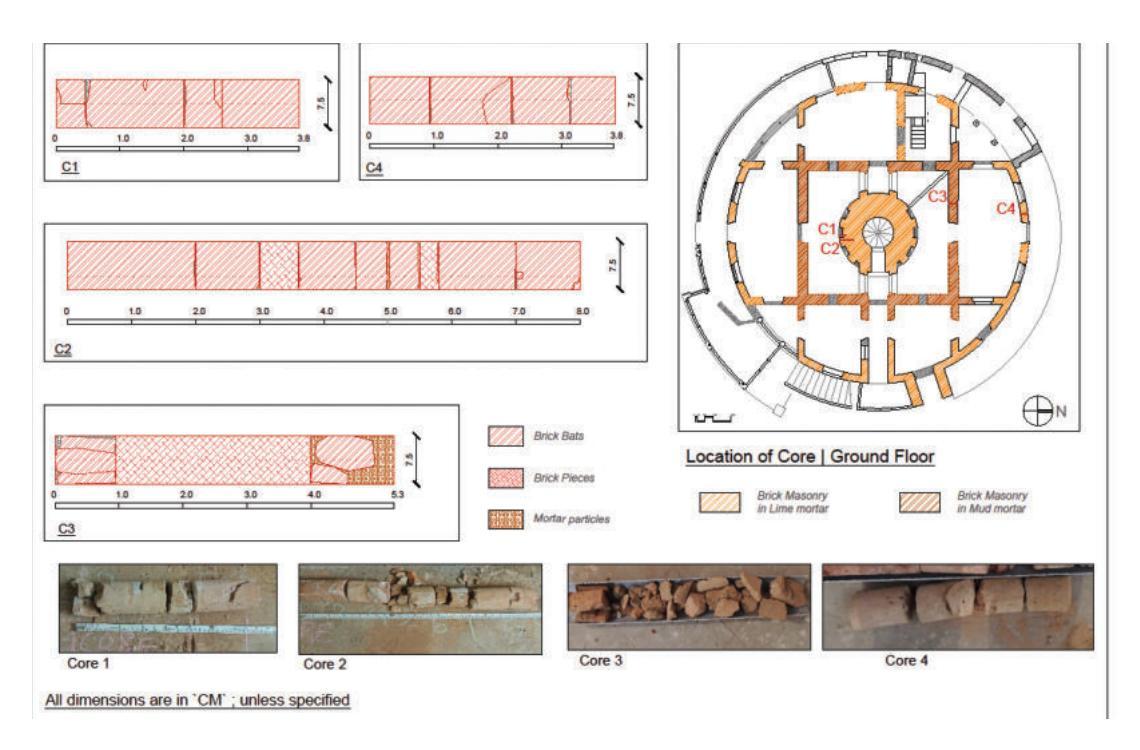
Figure 12: Masonry core section of Old Lighthouse Building.

Apart from these school buildings, Ecole Francaise d'Extreme-Orient (EFEO – Pondicherry Centre) on Dumas Street and Old Lighthouse on Goubert Avenue were two other buildings whose condition was assessed subsequently. Wet-core technique was employed in the three school buildings as well as in the Mairie Building. A conscious approach in examining the wall section of EFEO and Old Lighthouse structures was adopted. A dry core technique was adopted in this case to avoid washout of mortar (Figure 12, 13). Dry core technique is a time consuming exercise and it could result in quicker wear and tear of machine. A core of diameter 7 cm was extracted from the masonry. The quality of masonry bed joints was assessed thoroughly through this exercise. It was observed that here too similar intervention strategies as seen in other buildings were adopted i.e use of cement plaster as render.

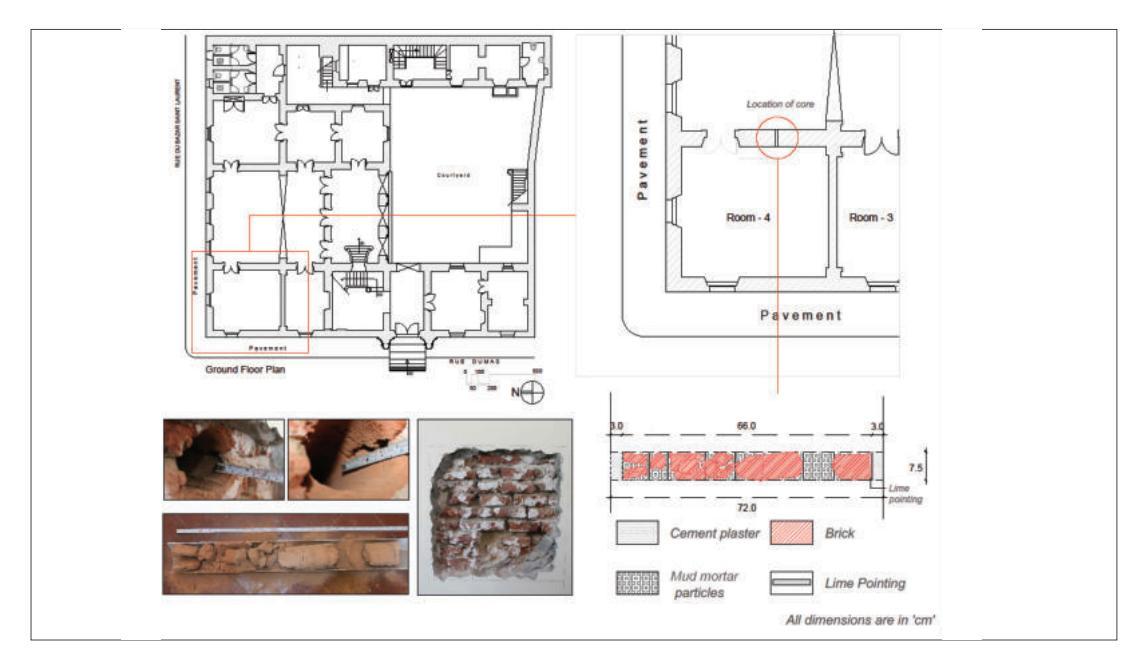
Figure 13: Masonry core section of EFEO Building.7
