Wall Morphology in Historic Buildings in Pondicherry

Hareesh Haridasan and Arun Menon

Tekton Volume 5, Issue 2, September 2018 pp. 34 - 49

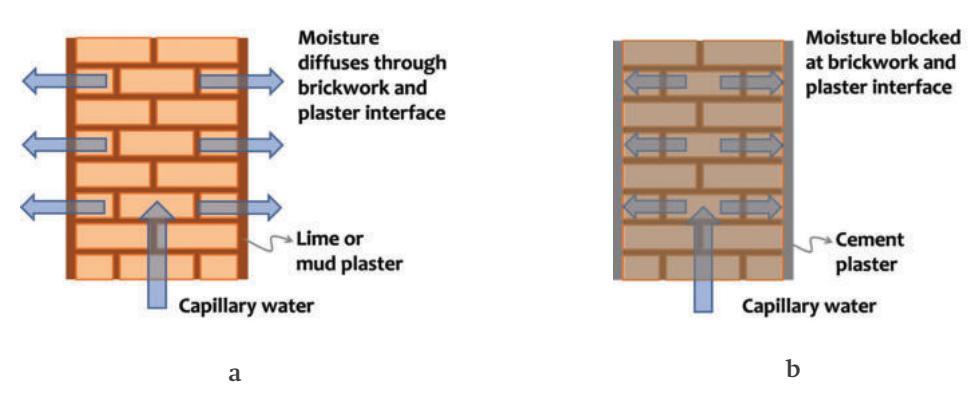
in the north-south axis. The removal of the cement plaster approximately 4 cm thick lead to compression failure in the load-bearing walls. This is confirmed by the formation of vertical cracks and bulging of plaster, which is a very rare phenomenon. Cement plastering being impervious, would trap the moisture, and retain it within the masonry walls which were laid in mud mortar and lime mortar. Wet mud has poor or no compressive strength; wet compressive strength of bricks is also lower than the dry compressive strength.

Figure 5: (a) Illustration showing behavior of moisture in brick masonry with mud/lime plaster; (b): Illustration showing moisture blocked in brickwork and plaster interface due to cement plaster

The thick cement plaster was on one hand trapping the moisture within the walls and on the other hand, was playing a structural role by confining the weakened walls and sustaining the load-carrying capacity of the wall. The use of cement plastering in such a building can be described as the single-most deleterious intervention that gradually led to the structural failure of the building (NCSHS, 2015). Thick rich cement plaster has clearly been observed in the load-bearing walls of the Mairie building (refer Figure 4). Possibly, the confinement provided by the cement plaster layer to a highly deteriorated brick wall in mud mortar was so critical as to lead to collapse on de-plastering.

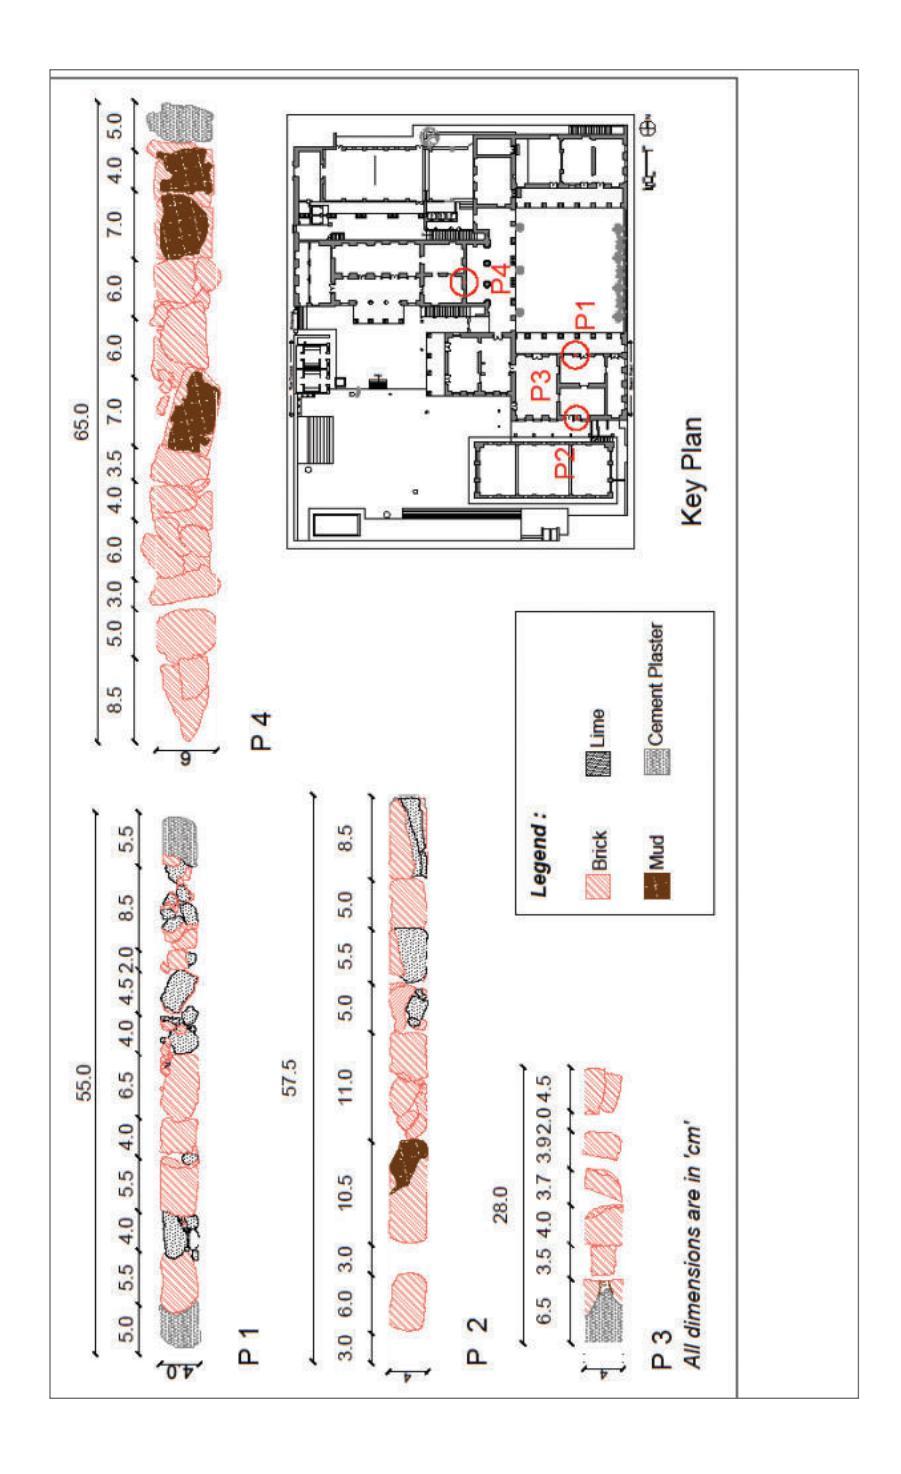
Figure 9: Masonry Core section from the VOC Government High School.

Mairie. Wet coring process was followed for these structures (**Figures 8, 9 10**). The core samples extracted were of 4 cm and 6.5 cm. Core extraction is a powered process in which heat is generated. Wet coring is preferred in order to keep the machine cooled and the blades clean when it is in use. However, the water jet is sufficient to wash out the mud mortar and could lead to moisture ingress in masonry. This issue of binding mortar washing out is not noticed in cement or lime mortar.
