In-situ Redevelopment for Slum Rehabilitation in Kolkata

Shreyonti Chakraborty, Shivashish Bose

Tekton
Volume 4, Issue 1, March 2017
pp. 40 - 53

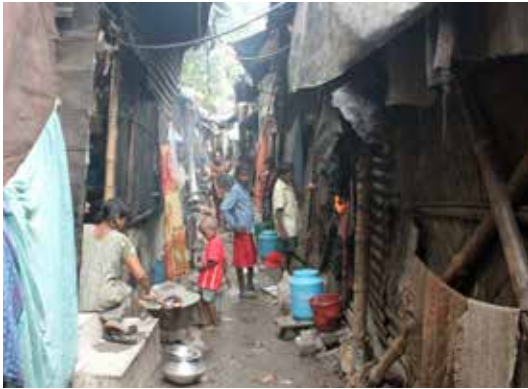
Figure 4: Narrow lanes of a slum

Units in a slum settlement are connected by narrow lanes (1.5 m or less), most of which are not kept clean and are used by

slum dweller to carry out daily activities like washing, bathing, drying clothes, cooking, parking of bicycles and so on (Figure 4). The lanes are also used as a communal space in

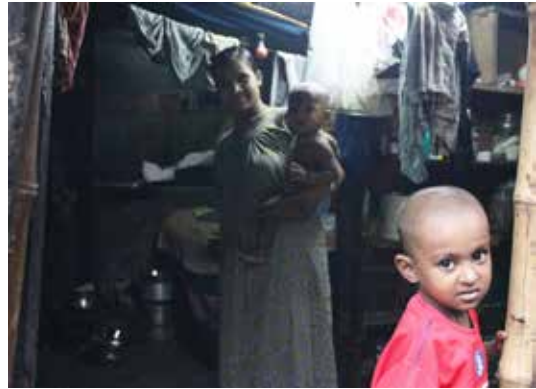
Figure 5: Interior of a slum-unit

Over the years, slums have been the sites of many outbreaks of fire. The materials with which the units are constructed and narrow lanes make the slums susceptible to fire damage (Figure 5). For example, in December of 2012, the explosion of several gas cylinders in Dum Dum Park's Harichand Palli resulted in a fire which was doused with great

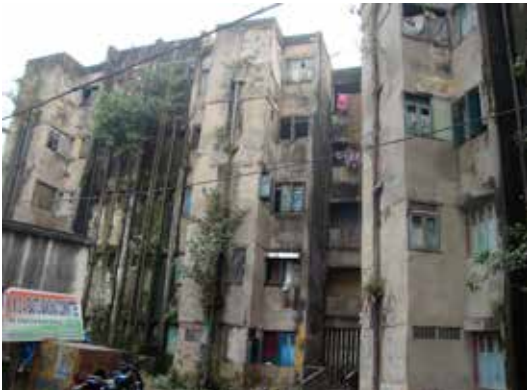
Figure 6: Dilapidated condition of a slum rehabilitation building at Chetla

So far, the policy of the local government centred on rehabilitation of slum dwellers in multi-storey buildings at an alternative location has not been fully successful (Figure 6). Slum dwellers themselves have stated the reasons behind their refusal to stay at government-provided housing off-site as: increased distance from workplace, inability to adjust in new accommodation above

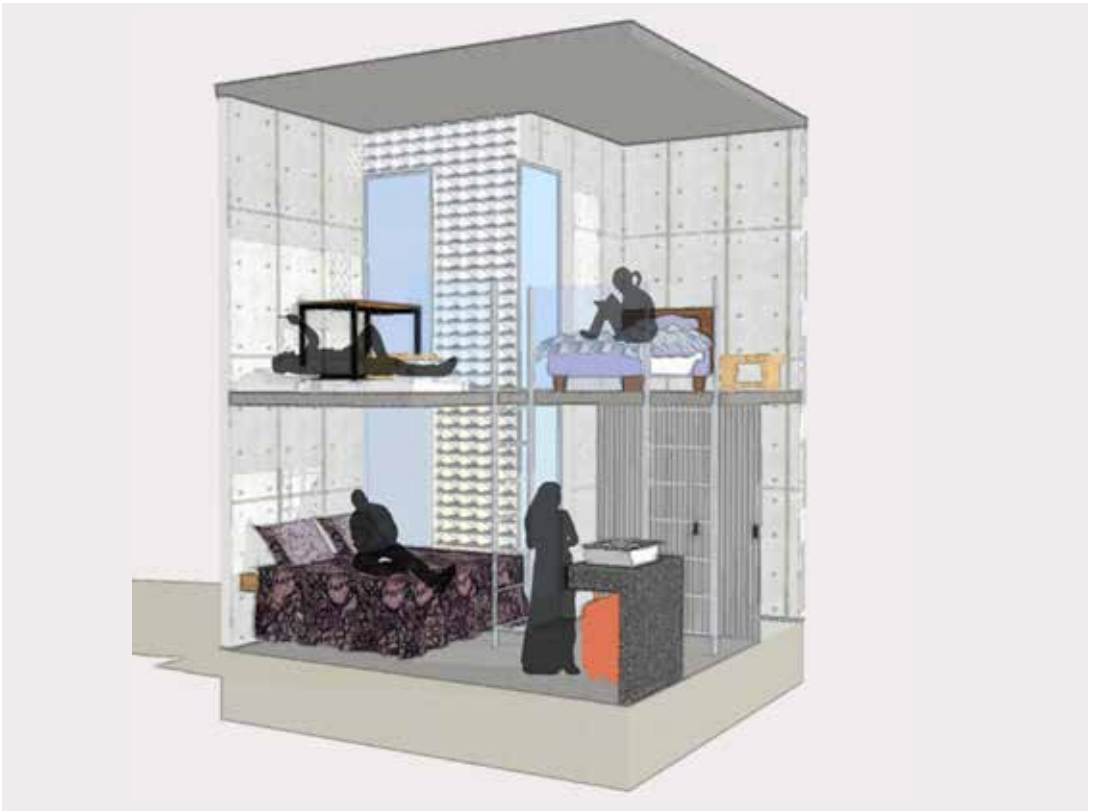
Figure 8: Conceptual view of proposed unit

gypsum panelled interior walls and pre-cast concrete floor slabs. The roof would consist of a steel beam-framework topped by galvanized iron colour-coated sheets. The building skin is designed using a metal framework and metal louvers painted white and etched glass panels where suitable. The cost of construction of the unit is estimated as Rs.8000 per sq.m., total cost of one unit would be Rs.1,29,000. A part of this may be funded by government schemes and remaining to be paid by the households in easy instalments.

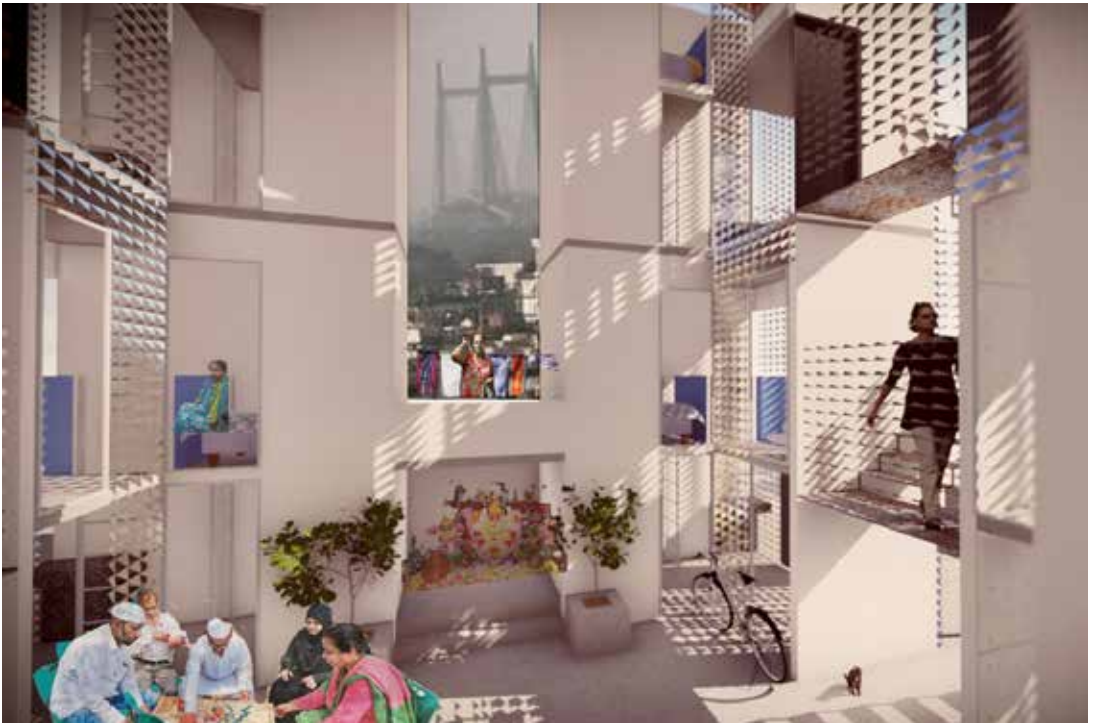
Figure 10: View of courtyard in slum-cluster

was a need for adequate shared open spaces for the slum dwellers for which, a community space in the form of a courtyard has been provided combining the L-shaped units (Figure 9, 10).
